# Job Completion & Handover

Sink trap replacement finished on site 16 Oct 2026. 0 documents listed · 0 attached · 0 to follow (worked out by Vitna). No open snags. Actions: Keep this pack. Turn off the water at the 1/2 inch angle valves (photo 2) and call a plumber.

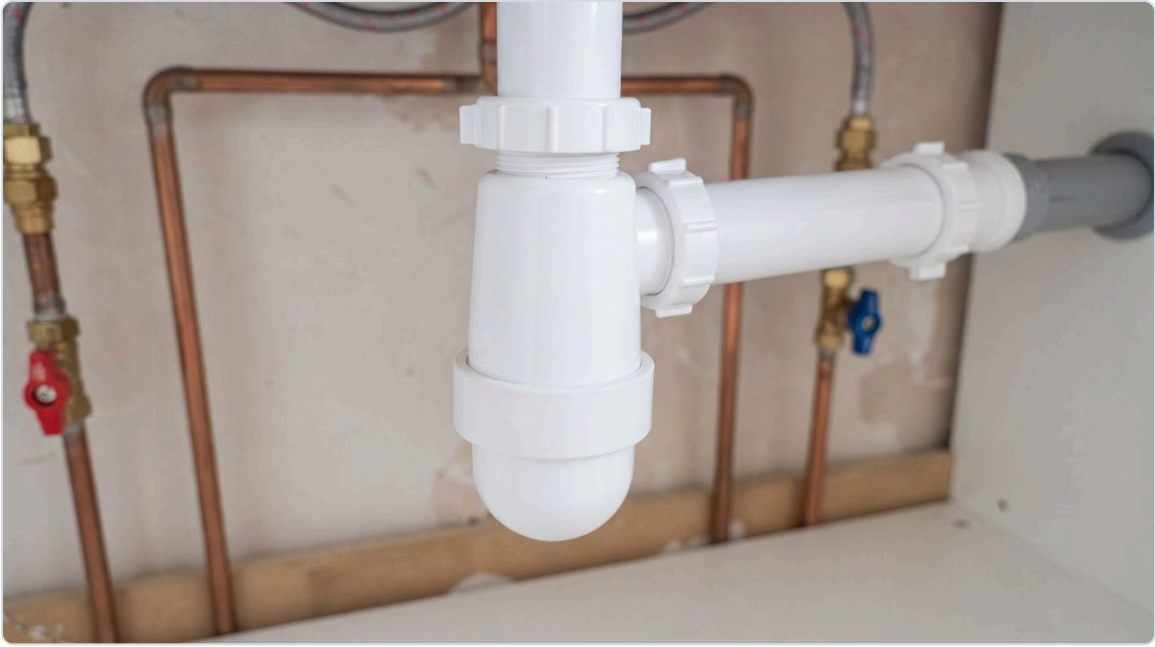
Photograph 1

No before photos. Under-sink area with new bottle trap and pipework, photo 5 (taken 14 Oct 2026). New bottle trap fitted under the sink, close-up, photo 1 (taken 14 Oct 2026). Angle valves and copper pipework, photo 2 (taken 14 Oct 2026). Bottle trap connection to waste pipe, photo 3 (taken 14 Oct 2026). Sink with running water, demonstrating drainage, photo 4 (taken 14 Oct 2026).

Item: Bottle trap Make and model: McAlpine STW4-S5 1.5 inch anti-siphon — Serial: Not typed. Where: Under kitchen sink — Photo: photo 1, photo 5

Done: The old kitchen siphon was replaced with a new 40 mm PVC bottle trap with a waste connection (Text note 2). An McAlpine STW4-S5 1.5 inch anti-siphon bottle trap was fitted, following manufacturer instructions (Text note 1). The 1/2 inch angle valves for the washing machine and dishwasher were closed (Text note 2). Leakage was checked with a 5-minute overflow test, showing zero drips at the connections (Text note 2). A machine test confirmed a full dishwasher cycle with no backflow to the sink (Text note 2).

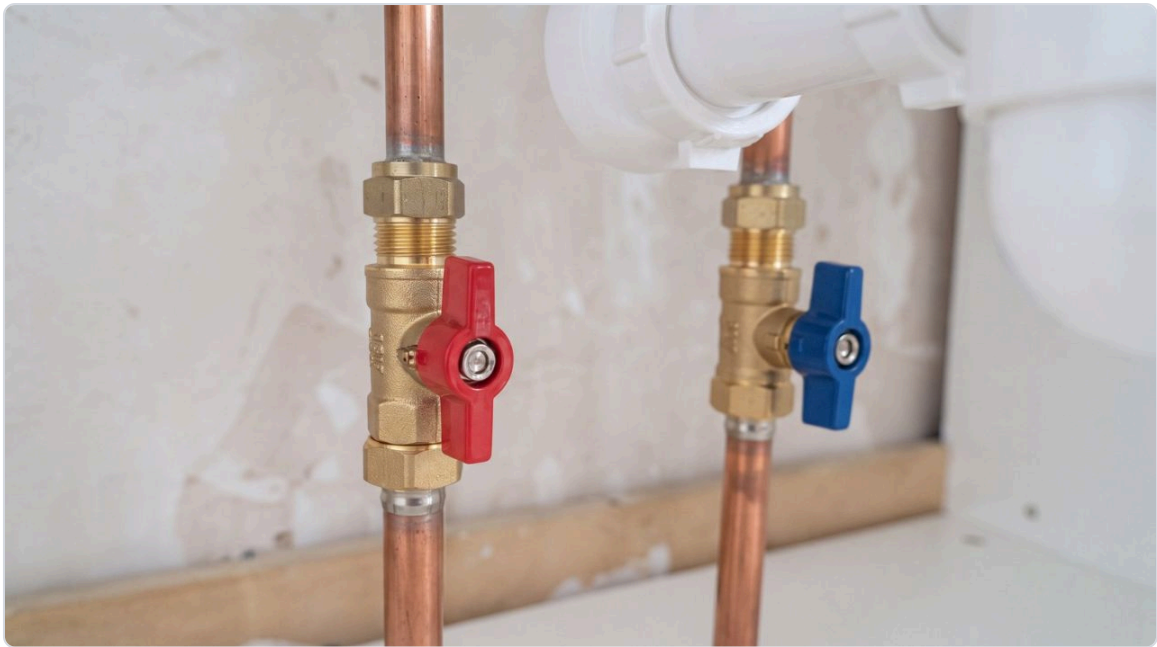
Photograph 2

Before you use it: No waiting times typed. Where to switch it off: The 1/2 inch angle valves for the washing machine and dishwasher (photo 2). Turn off the water at the 1/2 inch angle valves and call a plumber. Care and registration: No specific care or registration steps typed. Who to call: Insufficient evidence to assess contact details.
