# Standard Report - Gangpruefung Wagen 3 Hamburg

**Job:** Gangpruefung Wagen 3 Hamburg **Generated:** 16 Oct 2026, 02:29

### Cracked front passenger-side headlight lens on Ford Transit Van 3.

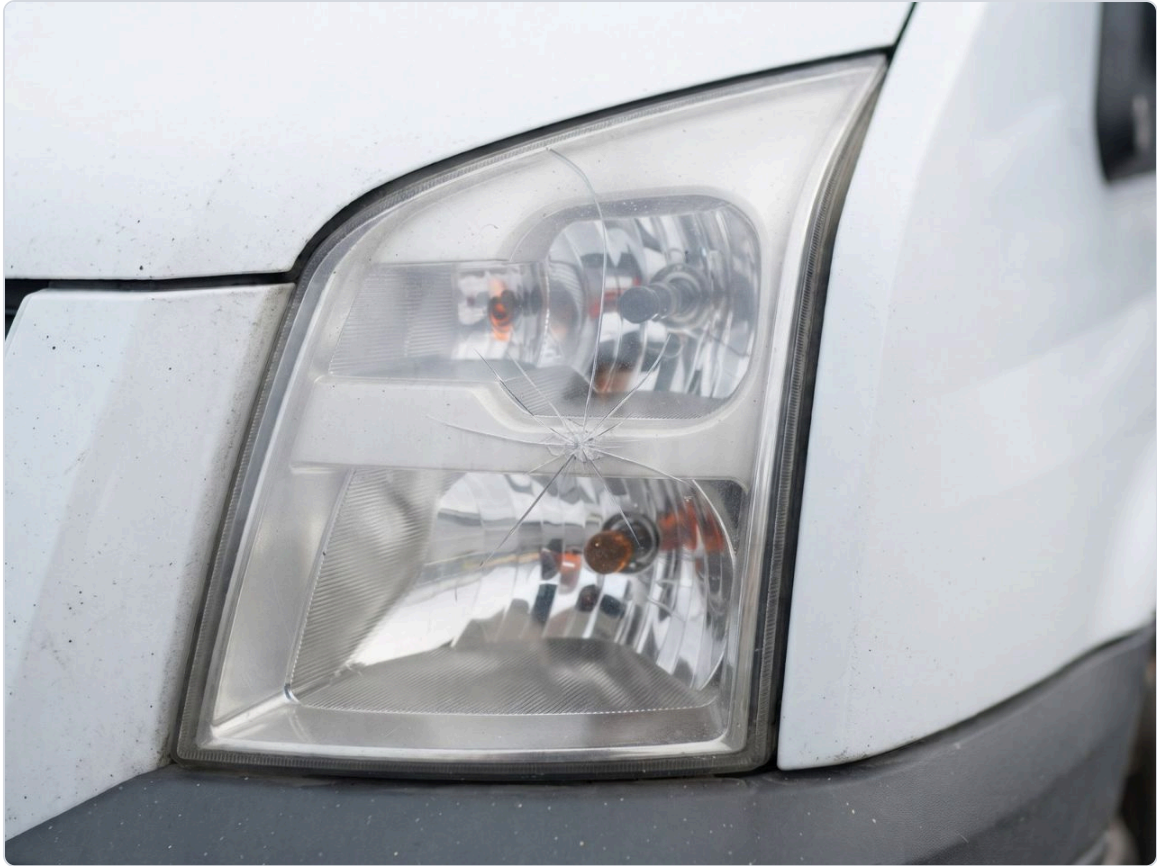
Photograph 3

Image 3 clearly shows a prominent crack extending across the front passenger-side headlight lens of the Ford Transit van. This damage compromises the integrity of the headlight, potentially affecting light output and allowing moisture ingress, which is an MOT failure point and a safety concern. The text note confirms an exterior inspection was performed, aligning with the visual evidence of this defect.

- Reduced night-time visibility
- Water ingress and electrical damage
- MOT failure and legal non-compliance

- Source a compatible aftermarket headlight unit
- Carefully remove the damaged headlight unit, disconnecting electrical connectors
- Install the new aftermarket headlight, ensuring secure fitment and proper electrical connections
- Test all headlight functions (dipped beam, main beam, indicator)
- Perform a basic headlight alignment check

- Source a high-quality aftermarket headlight unit from a reputable supplier
- Remove the damaged headlight unit, taking care to avoid any further damage to surrounding components
- Install the new headlight unit, ensuring all seals are correctly seated and connections are secure
- Thoroughly test all lighting functions
- Conduct a professional headlight alignment using specialised equipment to ensure optimal beam pattern and road legality

- Order a genuine Original Equipment Manufacturer (OEM) headlight unit directly from Ford or an authorised dealer
- Carefully remove and dispose of the damaged headlight unit
- Install the new OEM headlight, ensuring perfect fit, finish, and electrical integrity
- Verify all lighting systems operate as per manufacturer specifications
- Perform a precise, professional headlight alignment to factory standards
